1626 Ringling Boulevard, Suite 400 Sarasota, Florida 34236 Tel: (941) 927-8525 NDunning@karins.com

Milestone Inspection Report

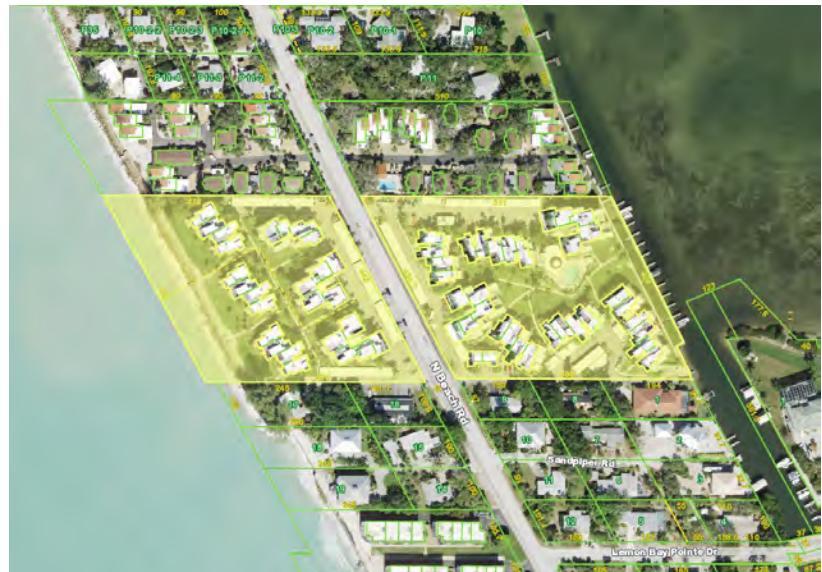
Figure 1: Ariel View of Parcel and Building.

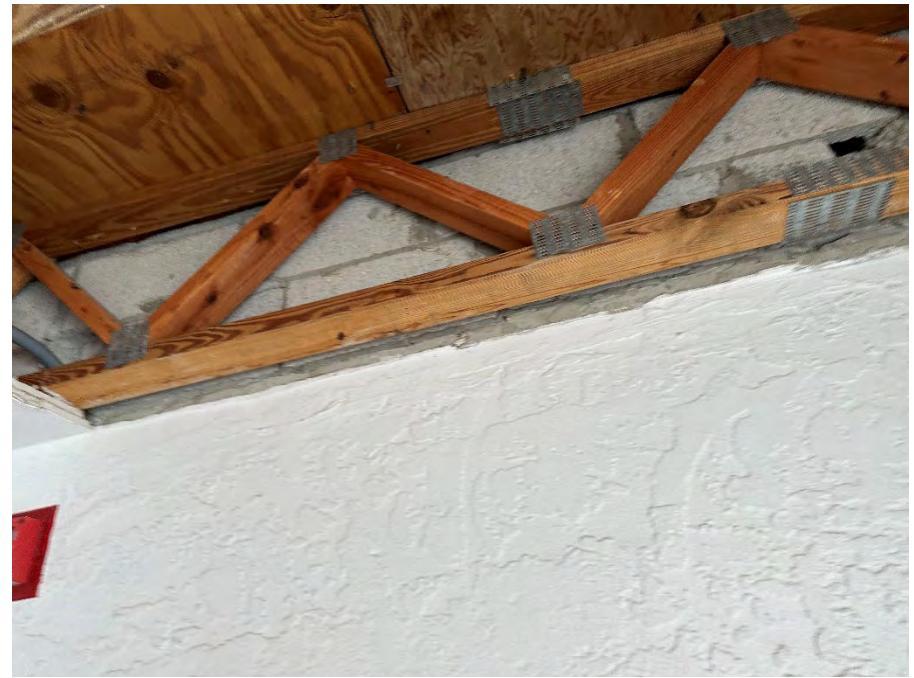
Figure 2: Typical Roof

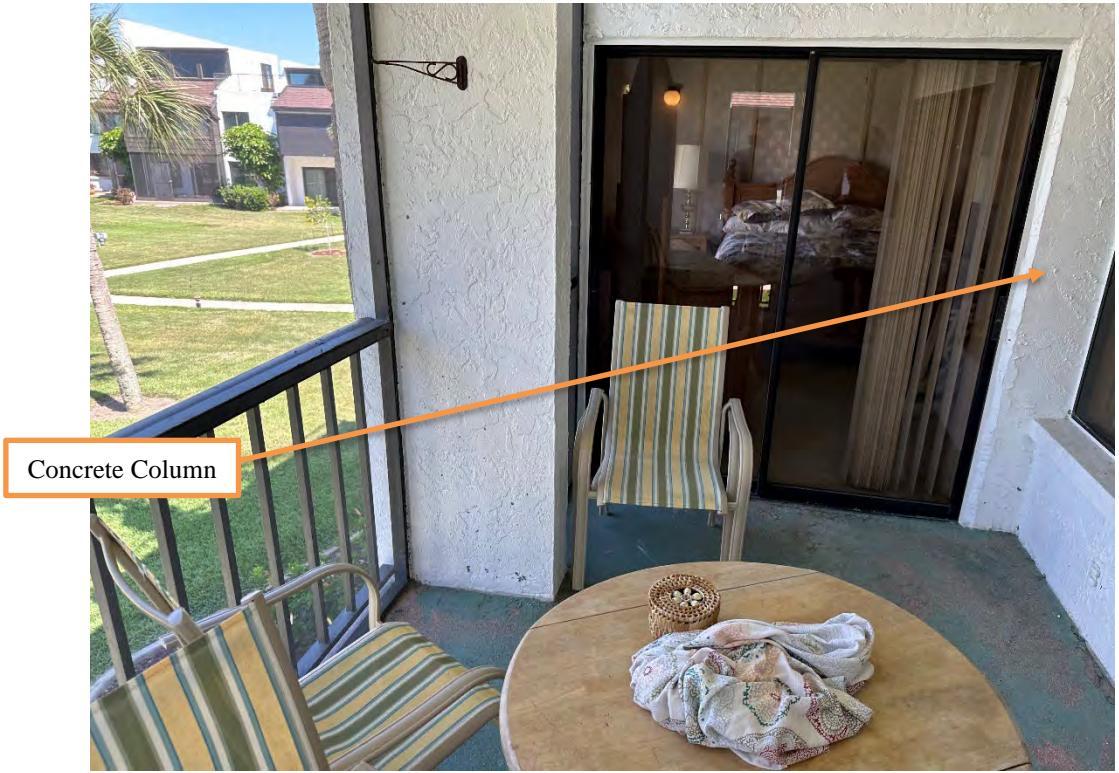
Figure 3: Typical Concrete Column

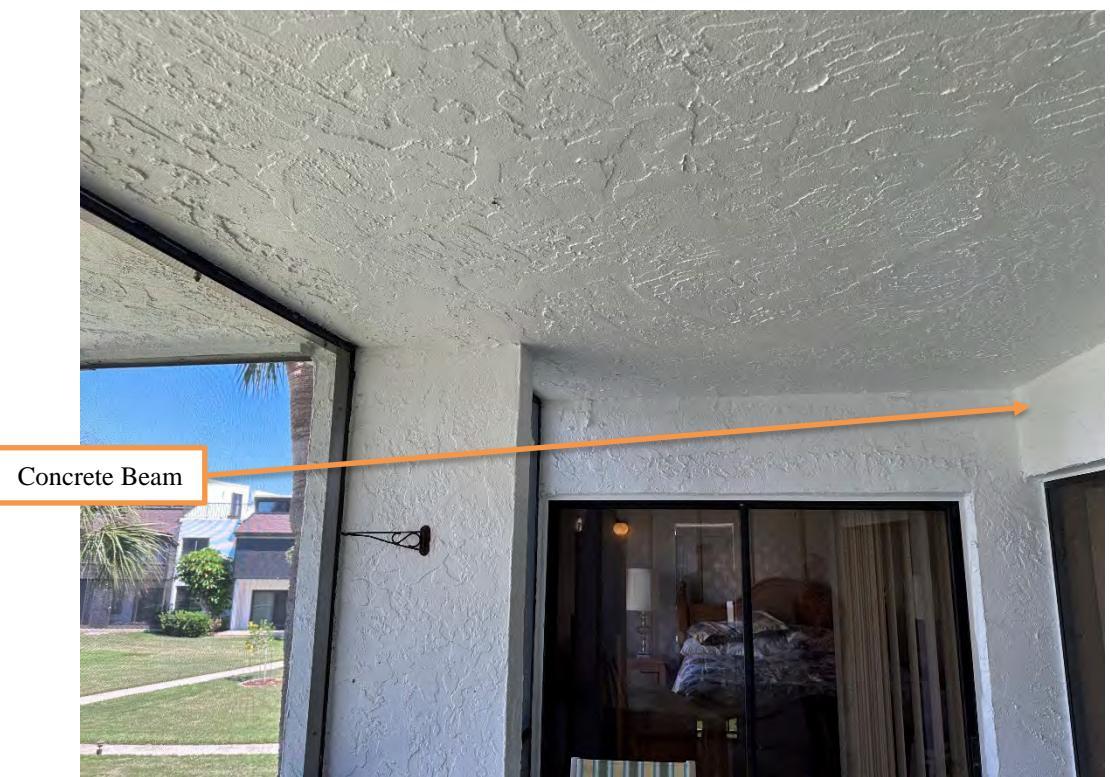
Figure 4: Typical Concrete Beam

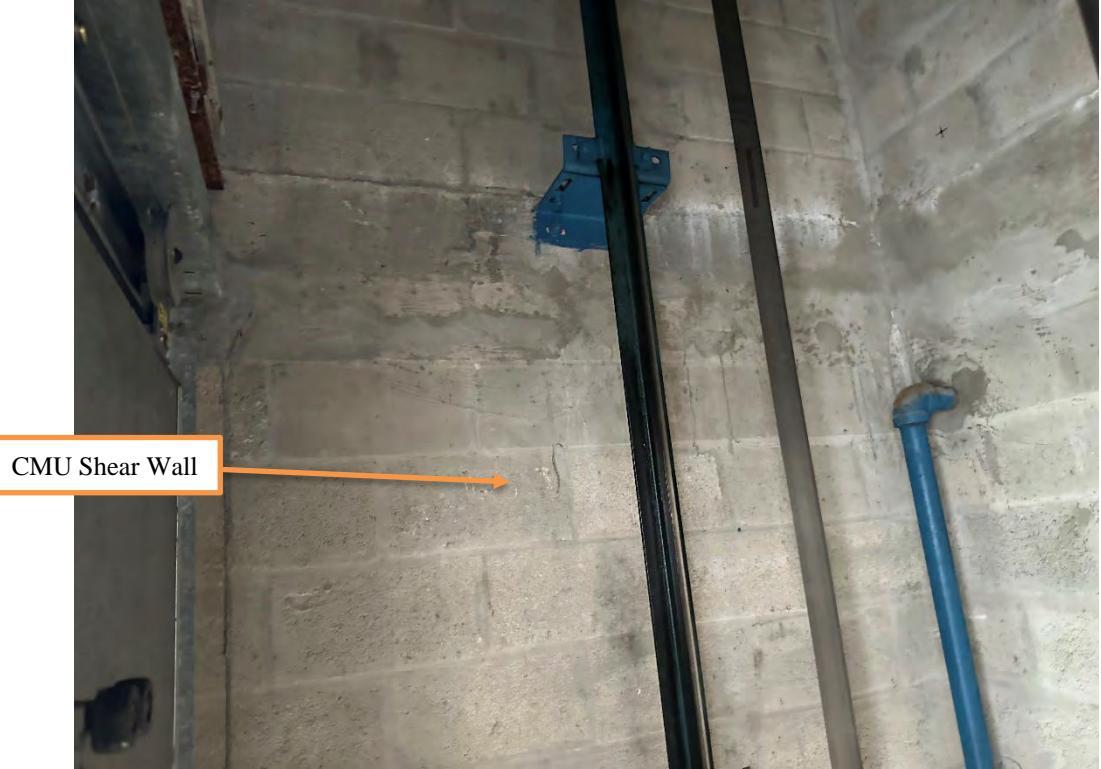
Figure 5: Elevator shaft (A5)

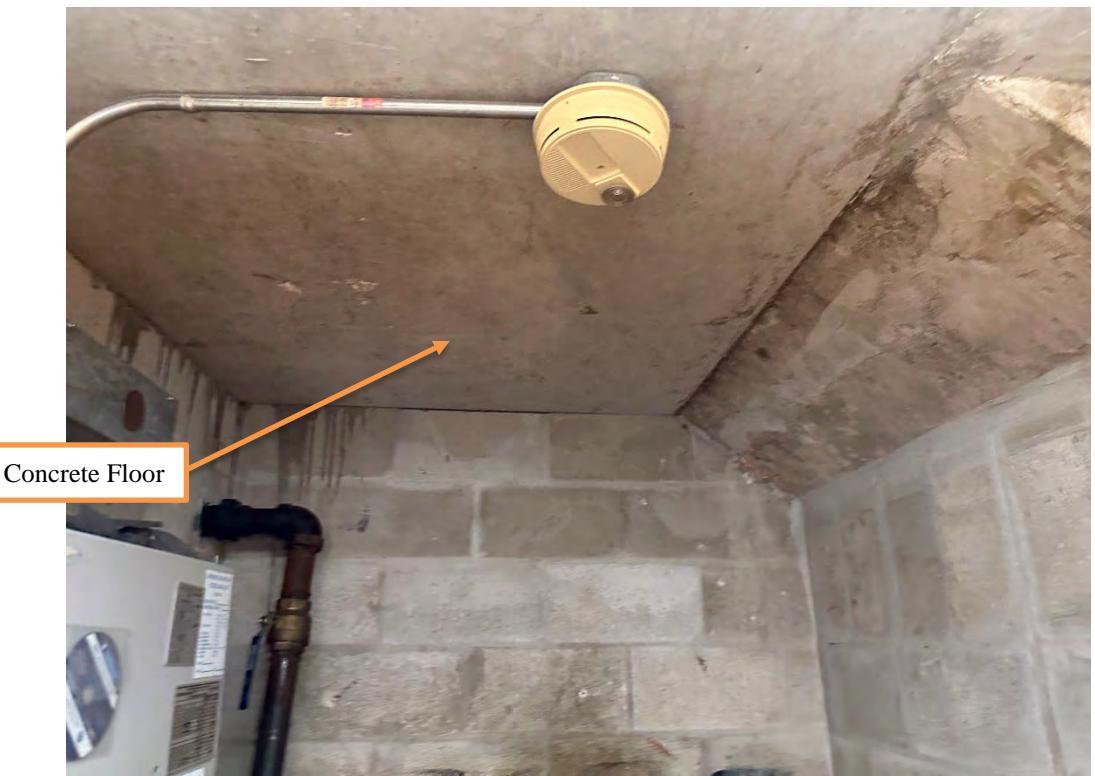
Figure 6: Electrical Closet

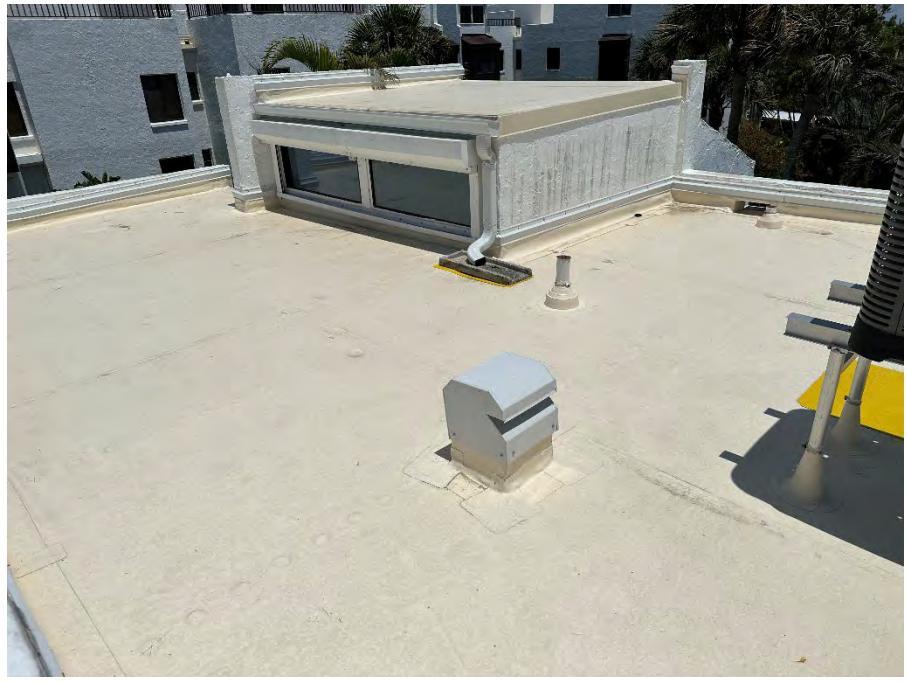
Figure 7: Typical Roof

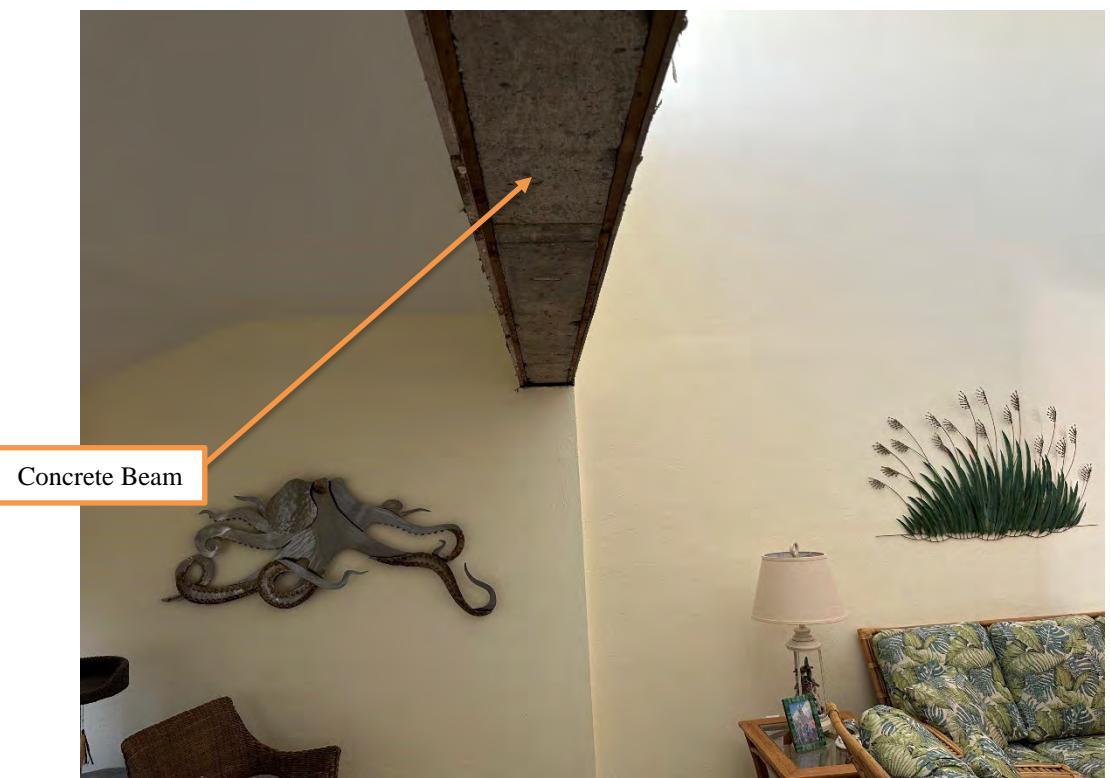
Figure 8: Typical Concrete Beam.

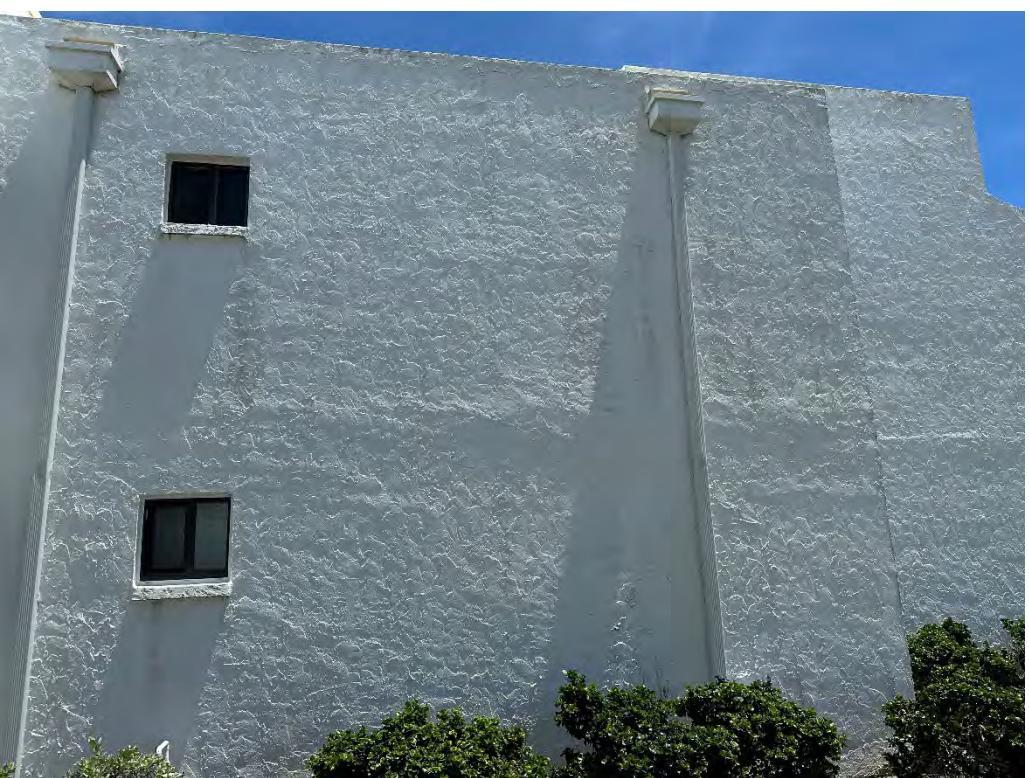
Figure 9: Typical Exterior Wall

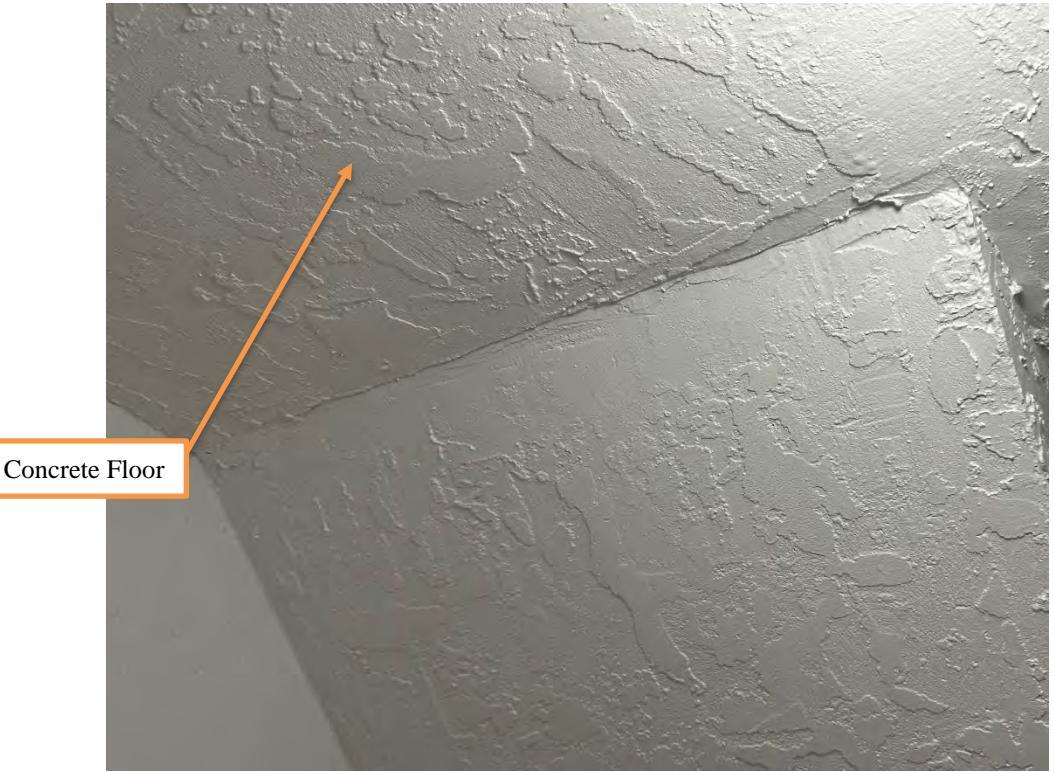
Figure 10: Concrete floor at landing

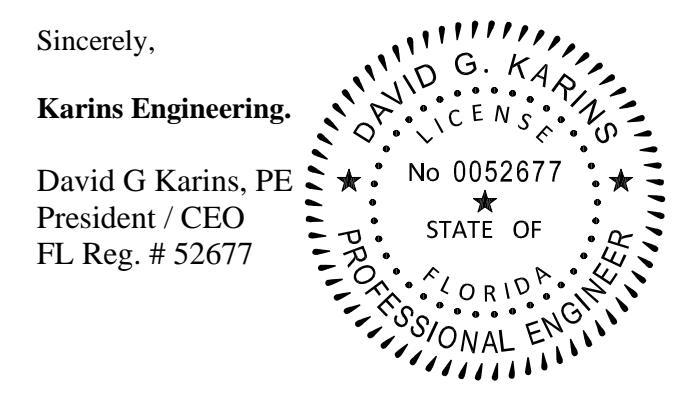
We trust this information is helpful. Should questions arise, please do not hesitate to contact us!

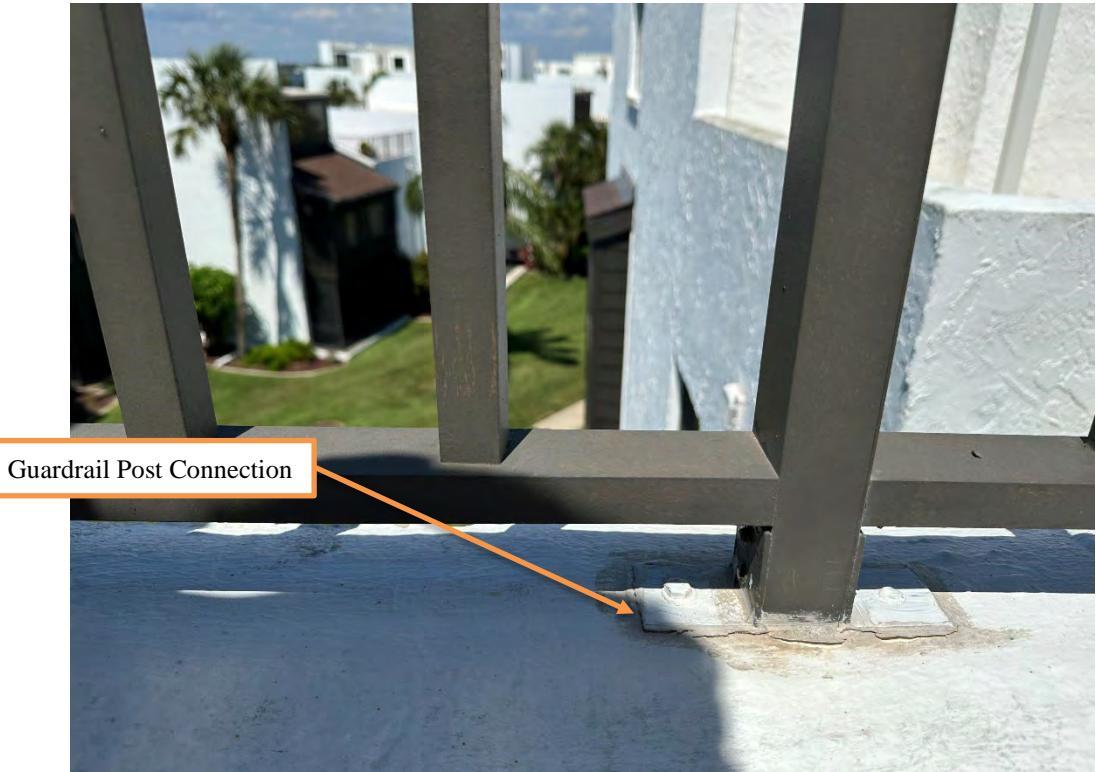
Figure 30: Loose Guardrail Post Connection

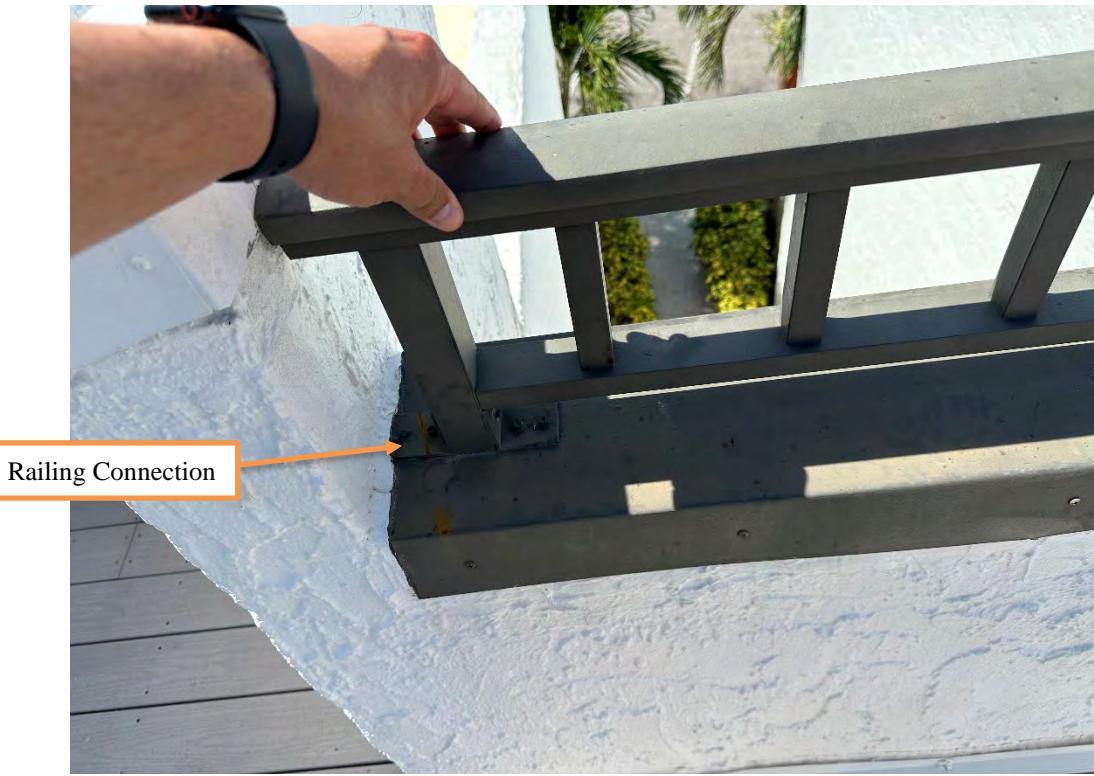
Figure 31: Loose Guardrail Post Connection

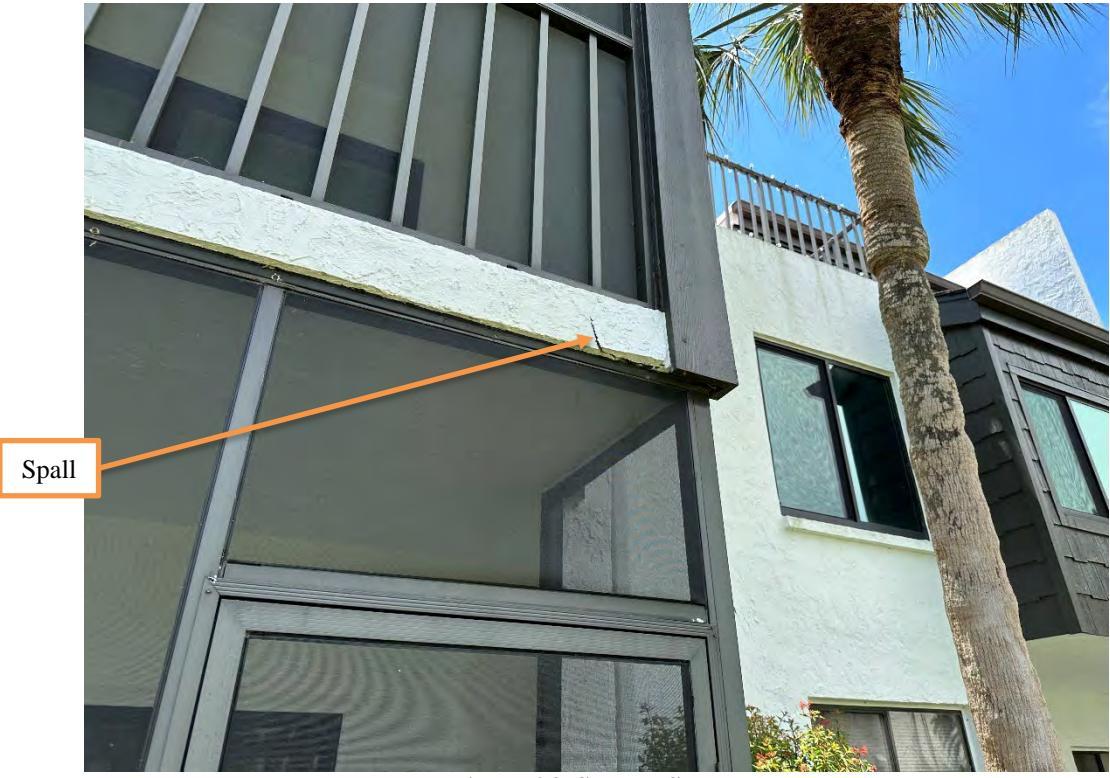
Figure 34: Spalled Stucco

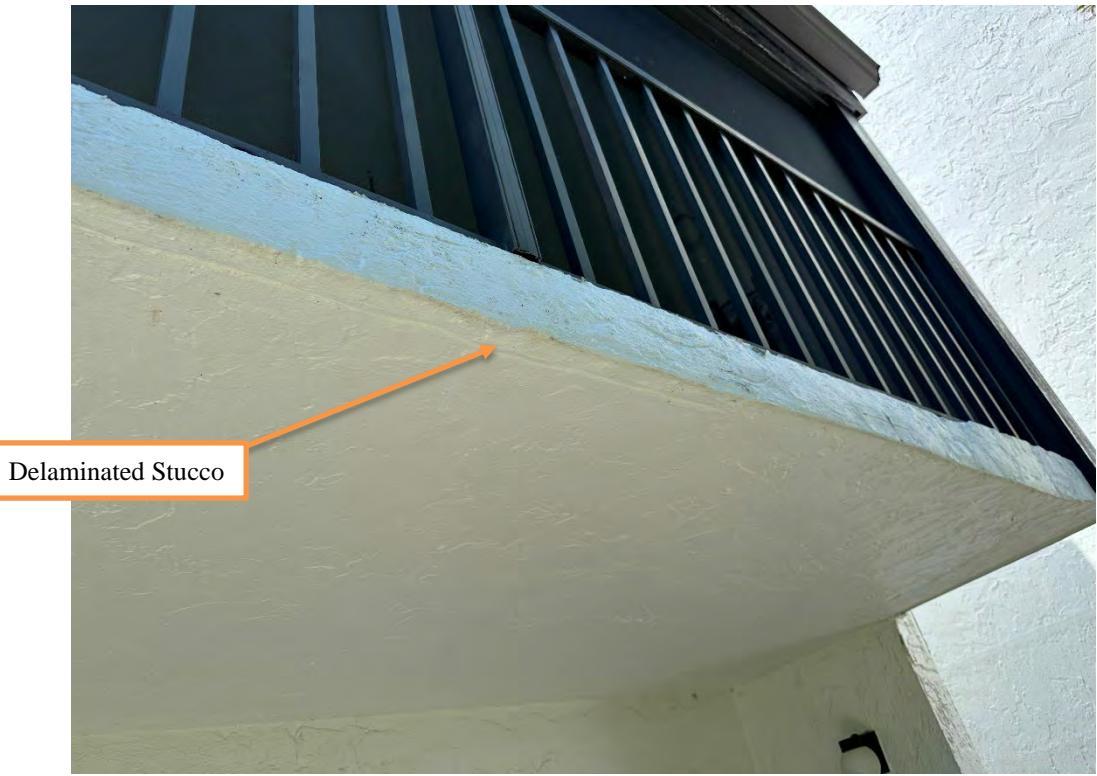
Figure 35: Delaminated Stucco at Balcony
